## Cheap Hummer Tricks - Aug 2004

### This month's Cheap Tricks: Reinforcing the H2 Tie Rod.

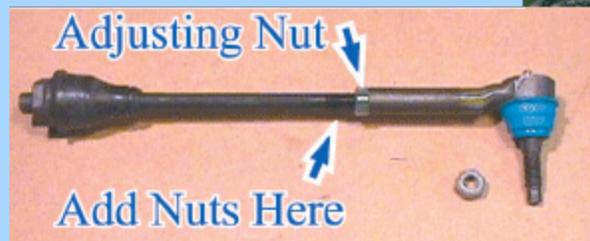
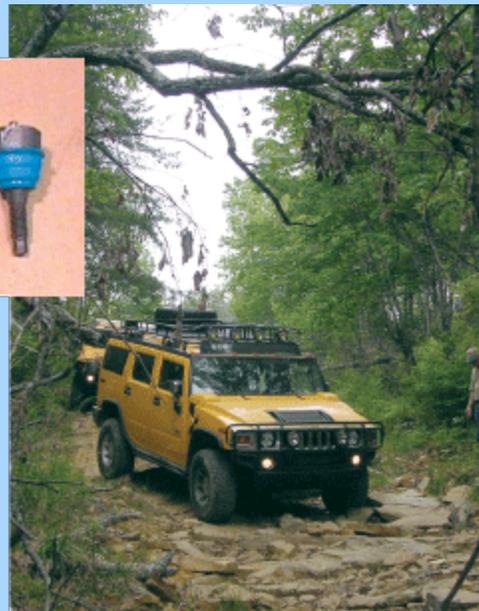
Picture 1 – Battery Terminal with Cover The trick: The inner Tie Rod is threaded for some distance to allow full adjustment for the front end alignment. Most (but not all) Tie Rod failures occur in this area. Placing additional nuts on this threaded section should make the Tie Rod slightly stronger. Picture 1 shows the factory adjusting nut, and the recommend location for the new nuts. Two or three nuts are usually all that will fit.

1. Raise the front tire with a jack
2. Determine how many nuts can be placed on the rod without interfering with the adjusting nut
3. Loosen the adjusting nut
4. Unthread the inner tie rod from the outer • Keeping the toe alignment adjustment is very important – count the number of turns required to separate the Tie Rod Ends
5. Remove the factory adjusting nut
6. Add the appropriate number of extra nuts – do not tighten at this time
7. Reinstall the factory adjusting nut
8. Reconnect the tie rod ends – thread them together the same number of turns counted in Step 4
9. Tighten the adjusting nut against the outer Tie Rod – tighten to 50 lb-ft
10. Tighten the extra nuts • Tighten the first against the adjusting nut • Do not allow the adjusting nut to move – it must remain tight against the outer Tie Rod End • Tighten each nut in turn against the previous

one You may wish to have the alignment checked following this procedure to make sure nothing was accidentally changed. This procedure can also be done when replacing the tie rod. The nut size is 14 x 1.5 (metric). The wrench required for this size nut is 22mm. A 13mm wrench is required to turn the inner Tie Rod End.
